# Space Mishaps

Apollo 1, Apollo 13, Challenger, and Columbia

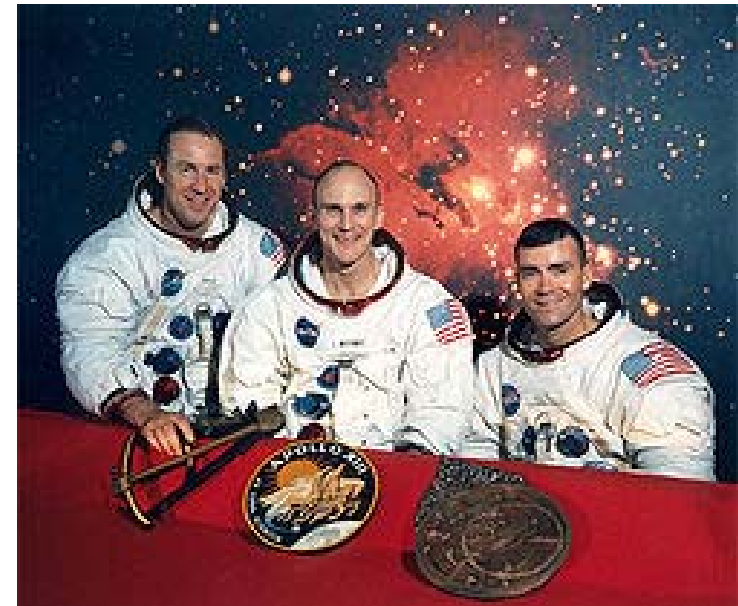
- The number two oxygen tank, one of two in the Service Module (SM), exploded.
- The resulting fire rapidly increased pressure beyond its nominal 1,000 PSI (7 MPa) limit and either the tank or the tank dome failed.
- All three astronauts survived.
  - James A. Lovell, Jr.
  - John L. Swigert, Jr.
  - Fred W. Haise, Jr.

- The other oxygen tank or its piping, located near the failed tank, was damaged allowing it to leak as well. Design changes included moving the tanks farther apart, adding a third tank, and an emergency battery to another sector in the service module.

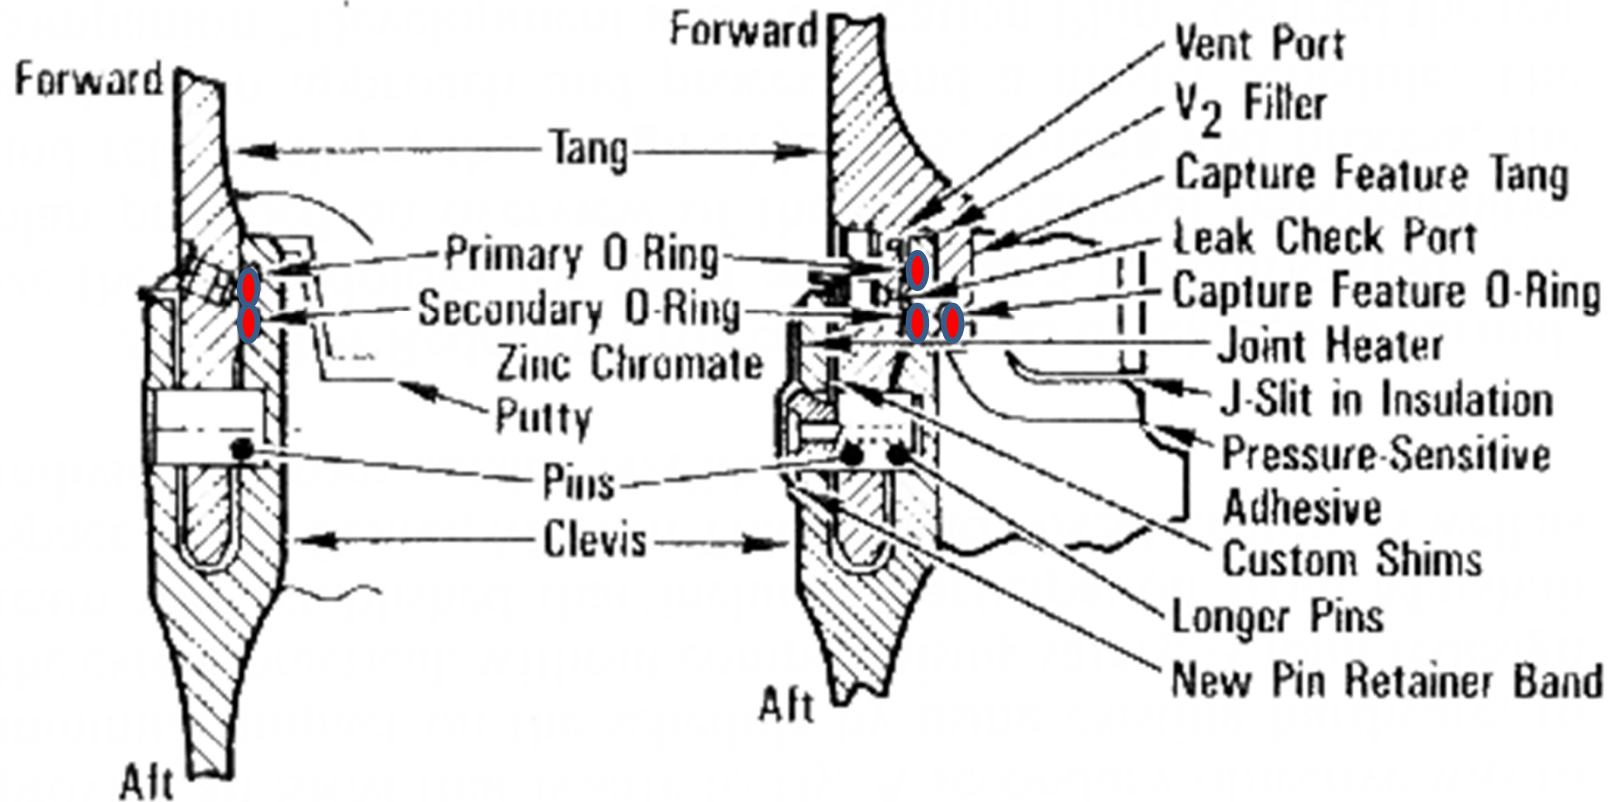
*Field Joint Comparison*

**Original  
Field Joint Design**

**Redesigned Solid  
Rocket Motor Improvements**

- The new design, with the tang capture feature, the interference fit, and the use of custom shims between the outer surface of the tang and inner surface of the outer clevis leg, controls the O-ring sealing gap dimension. The sealing gap and the O-ring seals are **designed so that a positive compression (squeeze) is always on the O-rings**. The minimum and maximum squeeze requirements include the effects of temperature, O-ring resiliency and compression set, and pressure. The clevis O-ring groove dimension has been increased so that the O-ring never fills more than 90 % of the O-ring groove and pressure actuation is enhanced.

- The new field joint design also includes **a new O-ring in the capture feature and an additional leak check port to ensure that the primary O-ring is positioned in the proper sealing direction at ignition**. This new, or third, O-ring also serves as a thermal barrier in case the sealed insulation is breached.

- The **field joint internal case insulation was modified to be sealed with a pressure-actuated flap called a J-seal**, rather than with putty as in the STS-51L configuration.

- **Longer field-joint-case mating pins, with a reconfigured retainer band**, were added to improve the shear strength of the pins and increase the metal parts' joint margin of safety. The joint safety margins, both thermal and structural, are being demonstrated over the full ranges of ambient temperature, storage compression, grease effect, assembly stresses and other environments. **External heaters with integral weather seals were incorporated** to maintain the joint and O-ring temperature at a minimum of 75 deg F. The weather seal also prevents water intrusion into the joint.

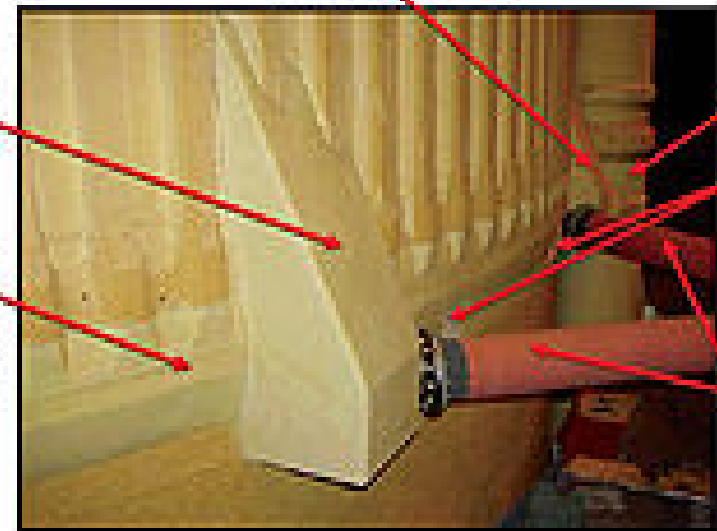
Bipod Ramp  
(+Y, Right Hand)

Liquid  
Oxygen  
Feedline

JackPot  
Standoff  
Close-outs

Bipod  
Struts

- NASA **added a heater to the LOX Feedline bellows and installing a foam "drip-lip"** that prevents condensation from building up and freezing as the liquid oxygen (LOX) feedline expand and contract as it carries fuel from the External Tank to the Orbiter.
